Protein purification troubleshooting guide

Pure protein today. Powerful results tomorrow.

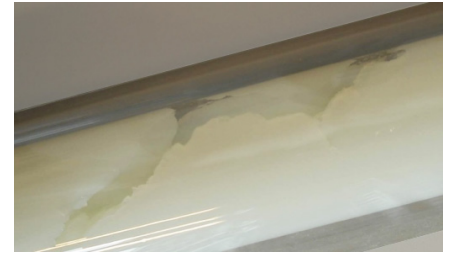
Air in the column

Bubbles in bed

Possible cause	Remedy
Buffers not properly degassed	<ul style="list-style-type: none">• Degas buffers thoroughly. Run degassed equilibration buffer through column to remove air.
Inappropriate sample loading or purification method construction	<ul style="list-style-type: none">• Use air sensors to prevent air from entering system
Column hardware inappropriately assembled or mechanically damaged	<ul style="list-style-type: none">• Ensure that column is correctly assembled and free from damage before packing
Blocked or partially blocked inlet filter	<ul style="list-style-type: none">• Change inlet filter or clean if possible
Column packed or stored at cool temperature and then warmed up	<ul style="list-style-type: none">• Remove small bubbles by passing degassed buffer through column• Take special care if buffers are used after storage in cold room or refrigerator• Do not allow column to warm up in sunshine or by heating system. If possible, repack column.

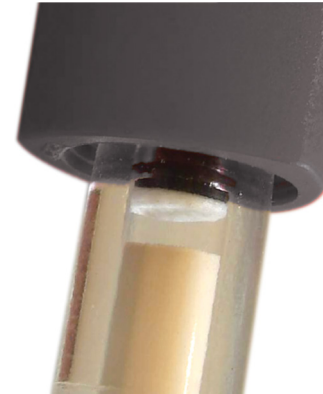
Compressed bed

Space between resin bed and adapter

Possible cause	Remedy
Back pressure increase or bed insufficiently packed	<ul style="list-style-type: none">• Turn down adapter to resin surface. Do a column performance test. Repack if needed.
Column packing not performed according to instructions	<ul style="list-style-type: none">• Repack according to recommended protocol
Flow rate too high	<ul style="list-style-type: none">• Do not exceed maximum flow rate for resin or prepacked column
Resin bed compressed	<ul style="list-style-type: none">• Repack using lower flow rate• Use prepacked columns• Check that system back pressure is not too high. Are there any restrictions in system?
Column operated at too high pressure	<ul style="list-style-type: none">• If using recommended flow rates, clean column according to instructions• Do not exceed recommended operating pressure for resin or prepacked column• For self-packed columns, use "Column handling" functionality in UNICORN™ system control software to save a defined column with its pressure data. Then select this method to protect this column type from too high pressure.
